BOEING AEROSPACE CO HOUSTON TX SPACE DIV
SNEAK CIRCUIT ANALYSIS OF F-4C FLIGHT CONTROL SYSTEM, (U)
SEP 74 P F STOKES

D2-118545-1

Sneak Circuit Analysis of F-4C Flight Control System

SEPTEMBER, 1974
HOUSTON, TEXAS

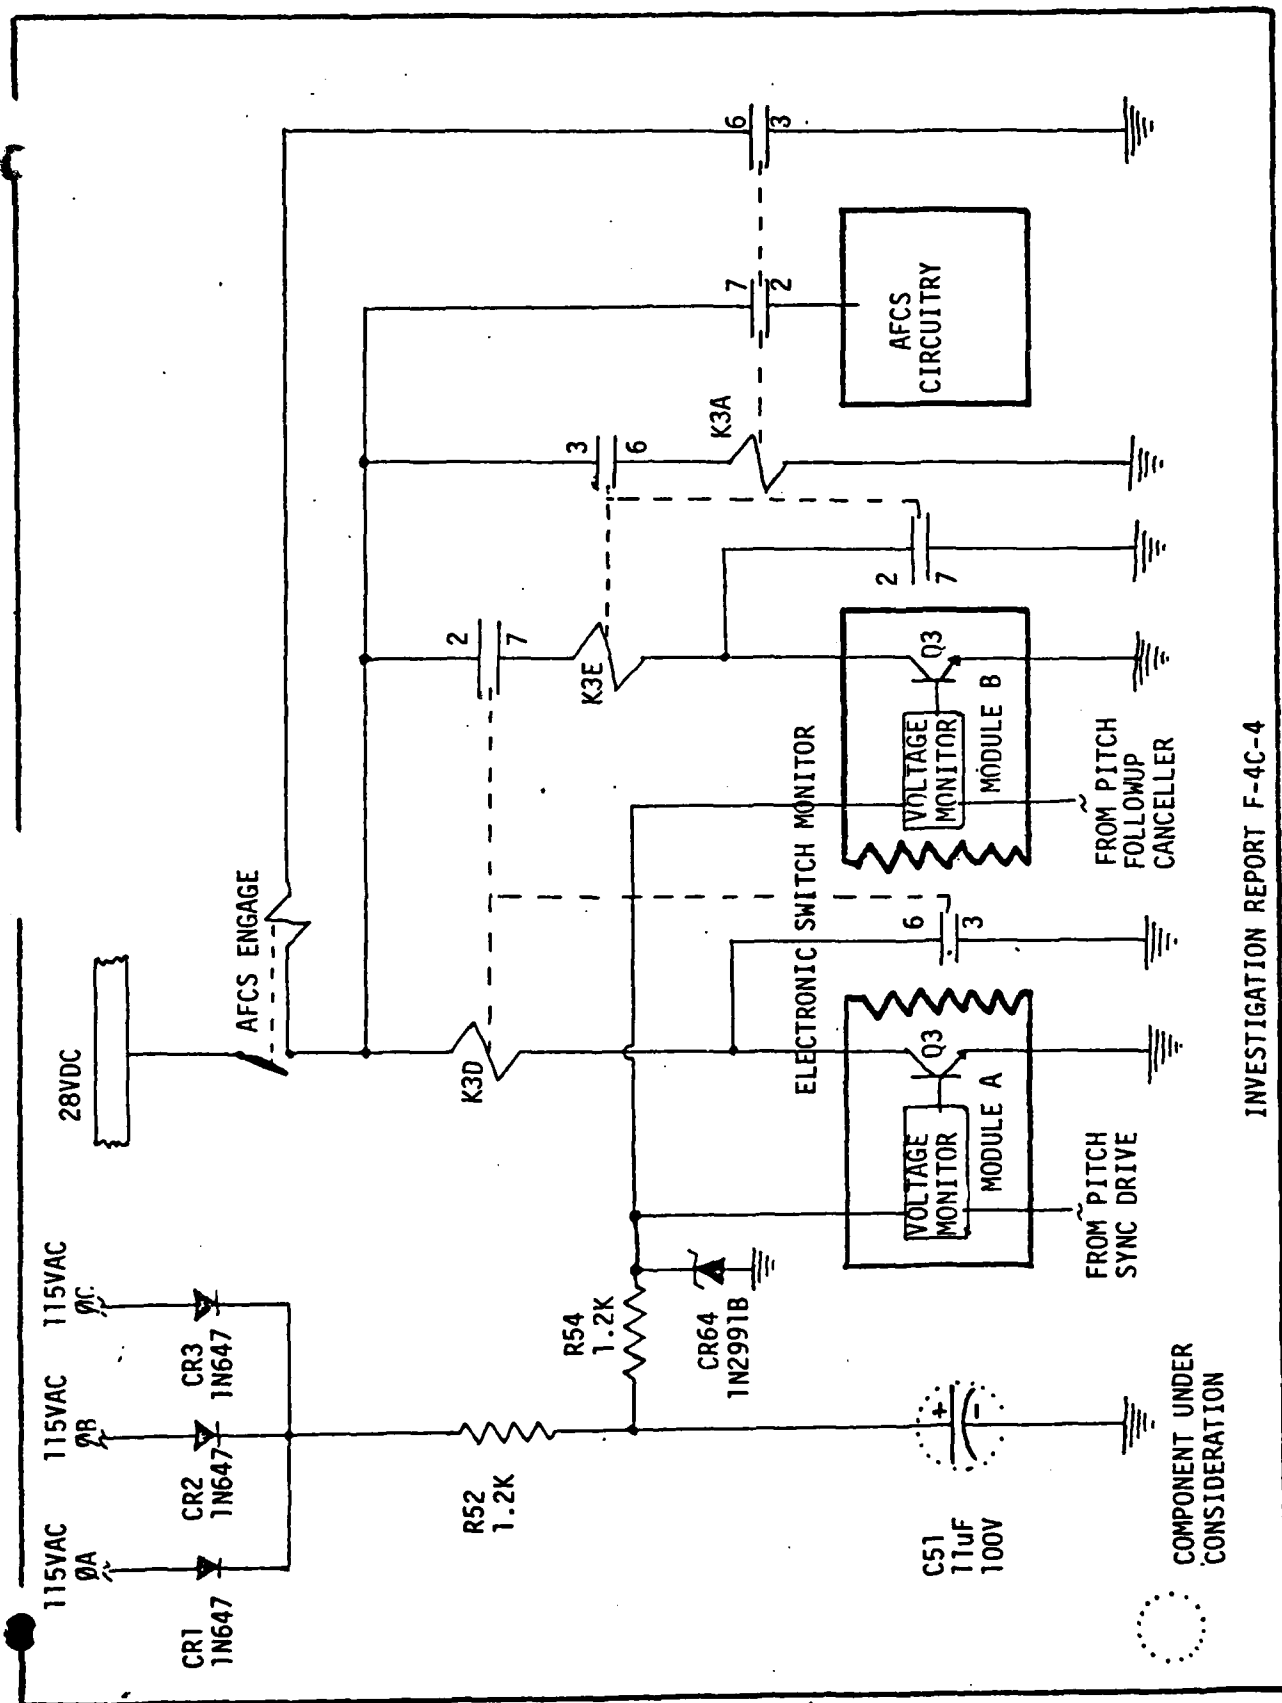
INVESTIGATION REPORT F-4C-4

Capacitor C51 is located in the B+ power supply circuitry of the Control Amplifier. If it fails shorted, the power supply for the Electronic Switch Monitor is shorted. The Electronic Switch Monitor is used to prevent AFCS engagement when a malfunction exists in the Pitch Sync Drive or Pitch Followup Canceller. With power to the Electronic Switch Monitor cut off, relays K3D and K3E lose their paths to ground, preventing AFCS engagement even when no malfunction exists in the pitch channel.

If C51 shorts while the AFCS is engaged, voltage to K20A is lost and it deenergizes, causing the Pitch Sync Brake to disengage and causing the Altitude Engage Clutch to engage. This has the effect of engaging altitude hold. The altitude of the aircraft at that time becomes the reference altitude for the altitude hold circuitry. This cannot be changed without disengaging the AFCS. Once disengaged, the AFCS cannot be reengaged.

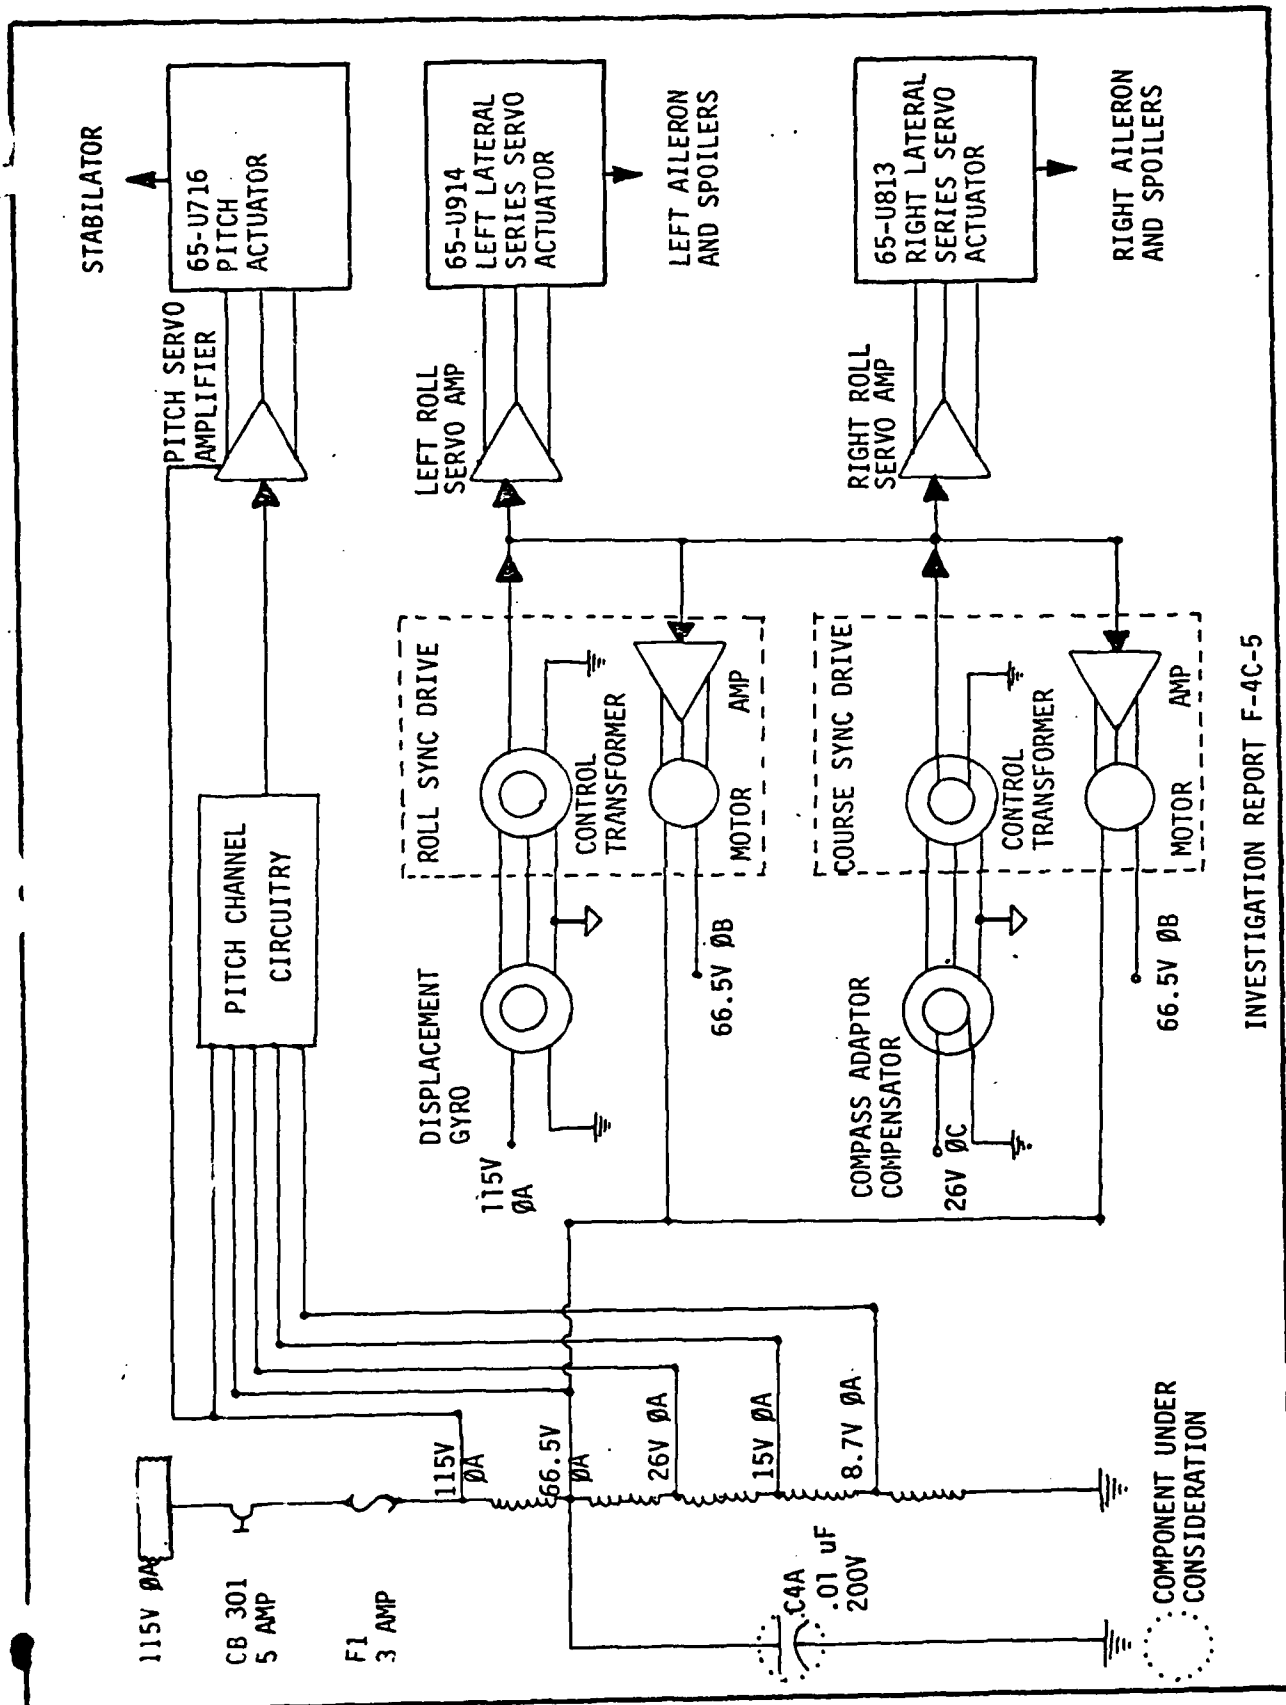
INVESTIGATION REPORT F-4C-5

Phase A also provides power for the fixed phase windings of the Roll Sync Drive Motor. The roll and course attitudes at the time of failure become the only attitudes that the AFCS can maintain. If a course or attitude change is required, AFCS must be disengaged.

Therefore, when C4A shorts, the pitch and roll channels of the AFCS are lost and the stabilator, ailerons, and spoilers must be manually controlled.

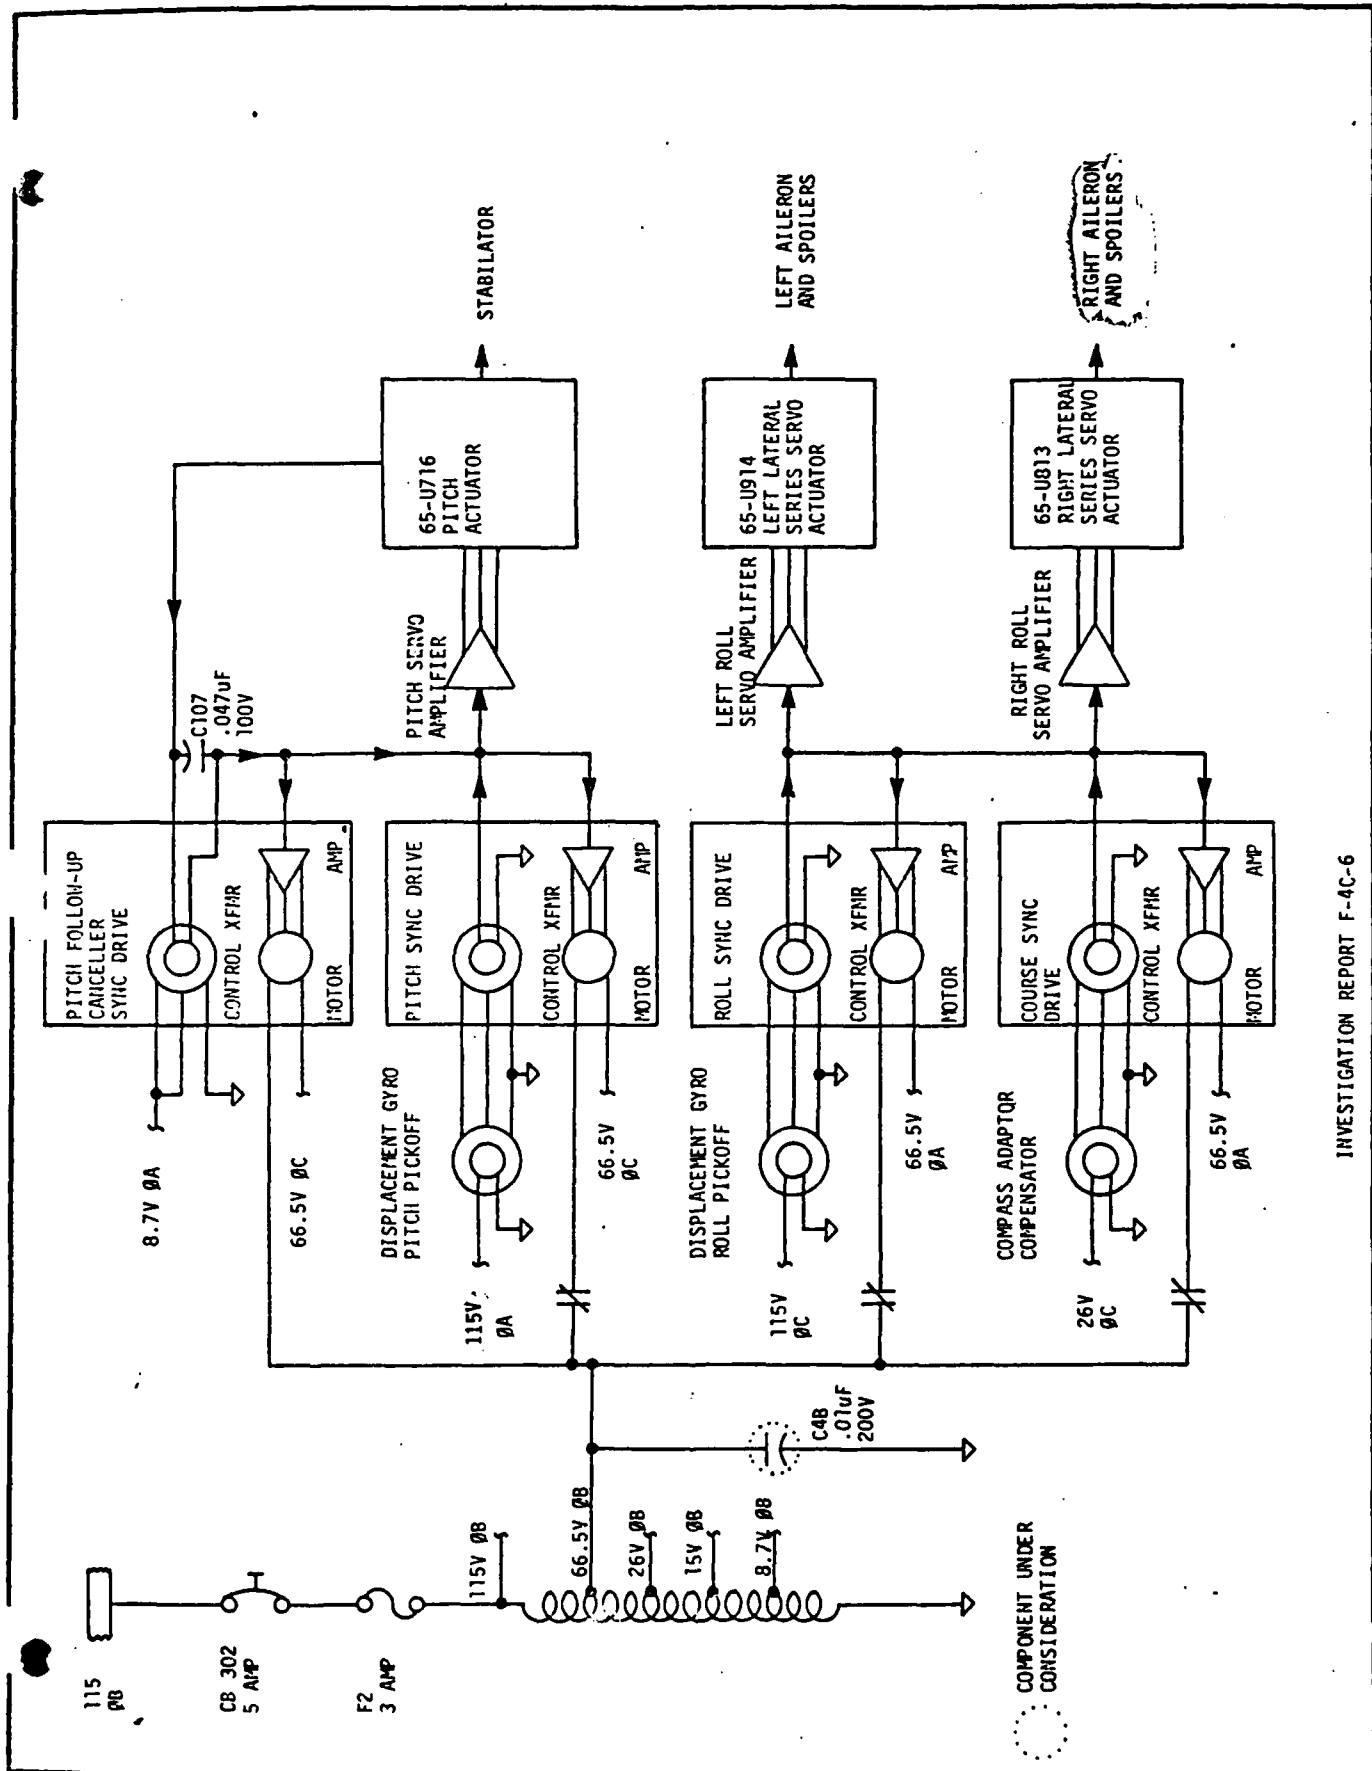
INVESTIGATION REPORT F-4C-6

Phase B provides power to the fixed phase windings of the Pitch Sync Drive Motor, Pitch Follow-up Canceller Sync Drive Motor, Roll Sync Drive Motor, and the Course Sync Drive Motor. The last pitch, roll, and course attitudes established for the aircraft before the failure cannot be changed unless the AFCS is disengaged.

Therefore, when C4B shorts, the pitch and roll channels of the AFCS are lost and the stabilator, ailerons, and spoilers must be manually controlled.

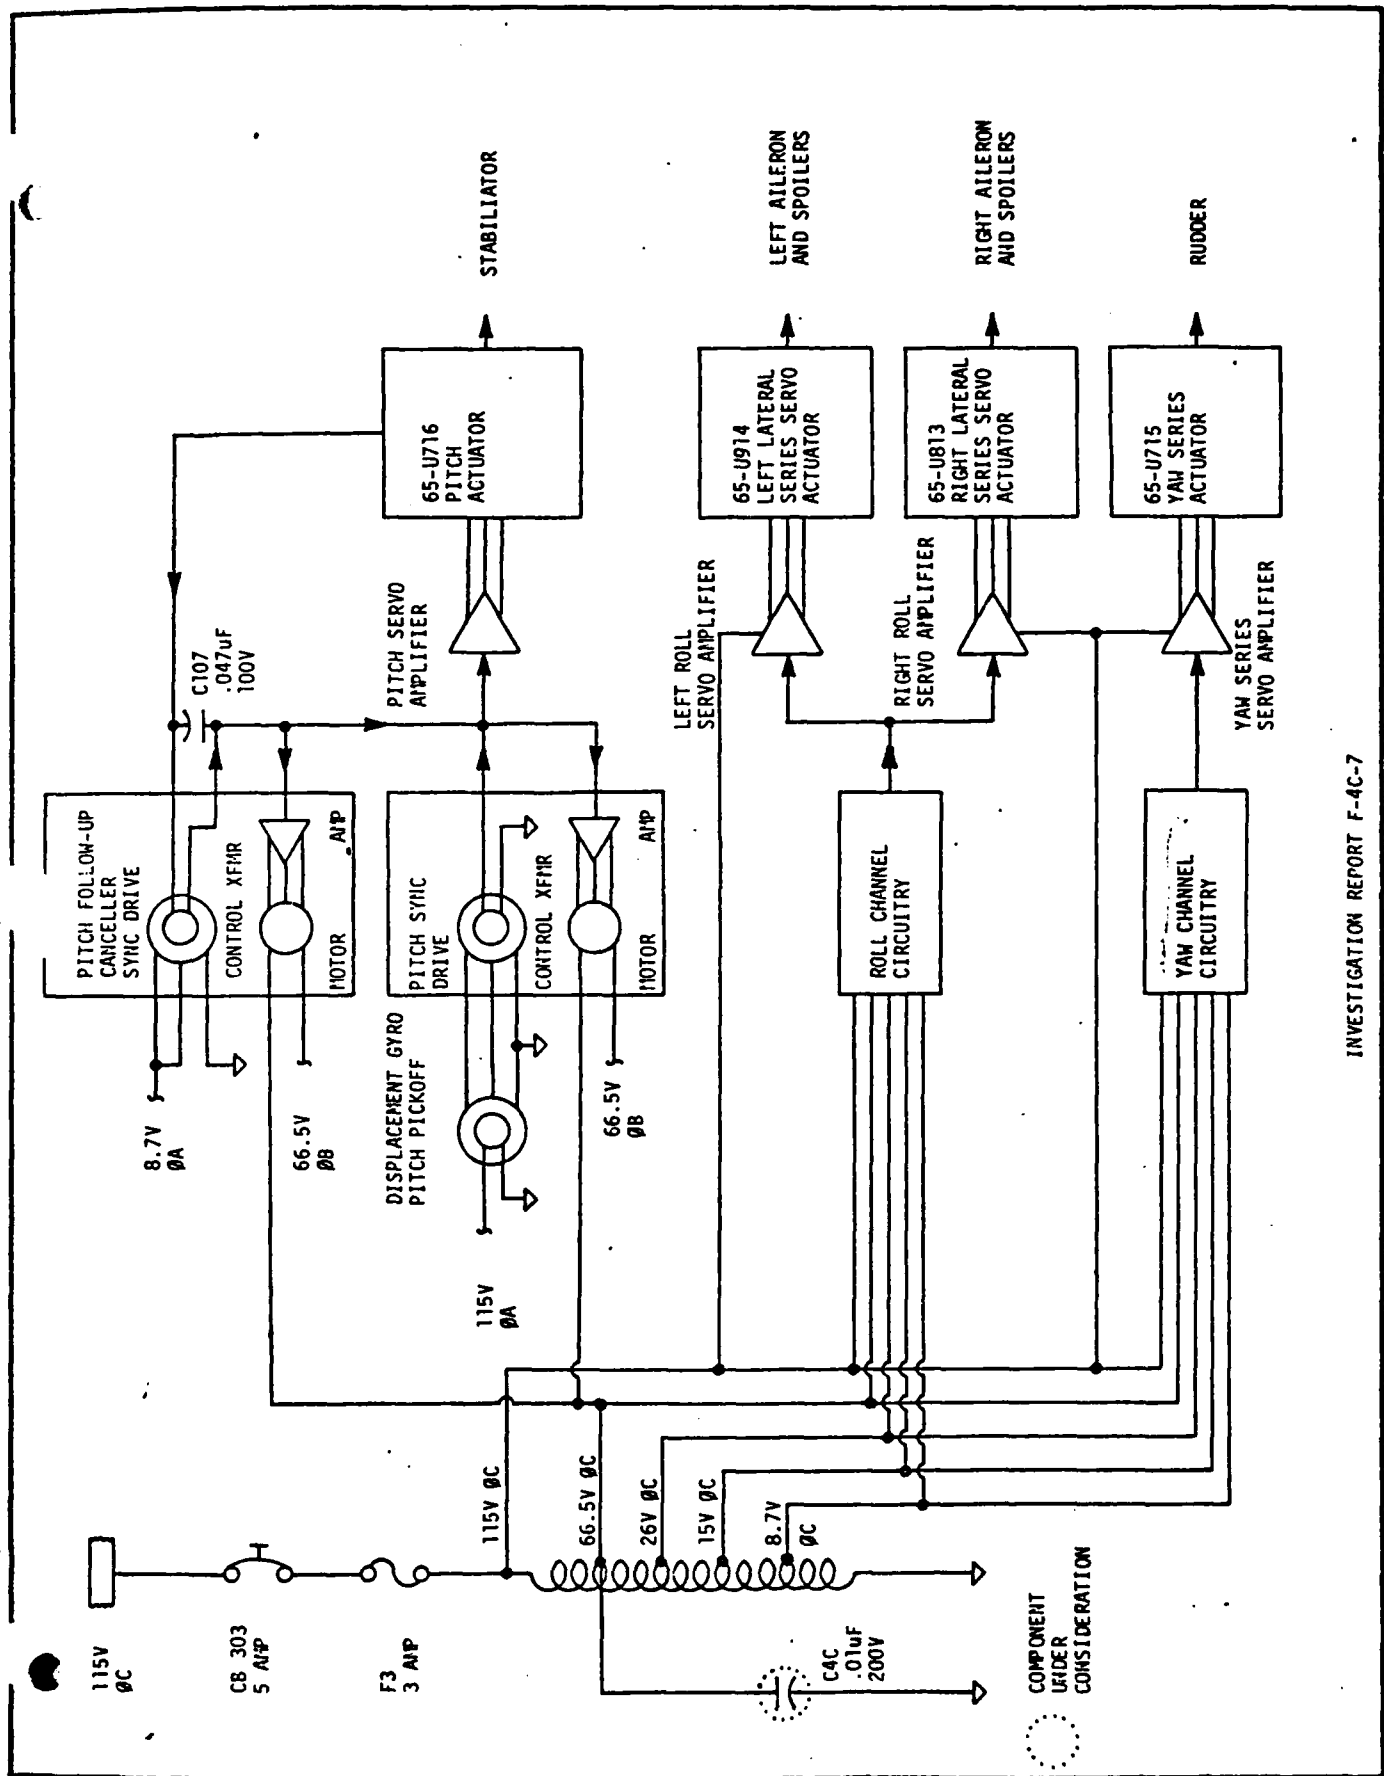
INVESTIGATION REPORT F-4C-7

Phase C also provides power to the fixed phase windings of the Pitch Sync Drive and Pitch Follow-up Canceller Sync Drive motors. The pitch attitude at the time of capacitor C4C failure becomes the reference attitude for the pitch channel of the AFCS. If the aircraft is not at this attitude, the AFCS cannot be engaged. If it is, the AFCS can be engaged, but the attitude will not be maintained since the Pitch Follow-up Canceller Sync Drive will be unable to create artificial stabilator null positions to compensate for fuel consumption, stores release, etc. As these slow changes occur, the aircraft will gradually drift off its pitch reference attitude.

The result of a C4C capacitor failure is, therefore, total loss of the yaw and roll autopilot channels and for all practical purposes loss of the pitch autopilot channel.

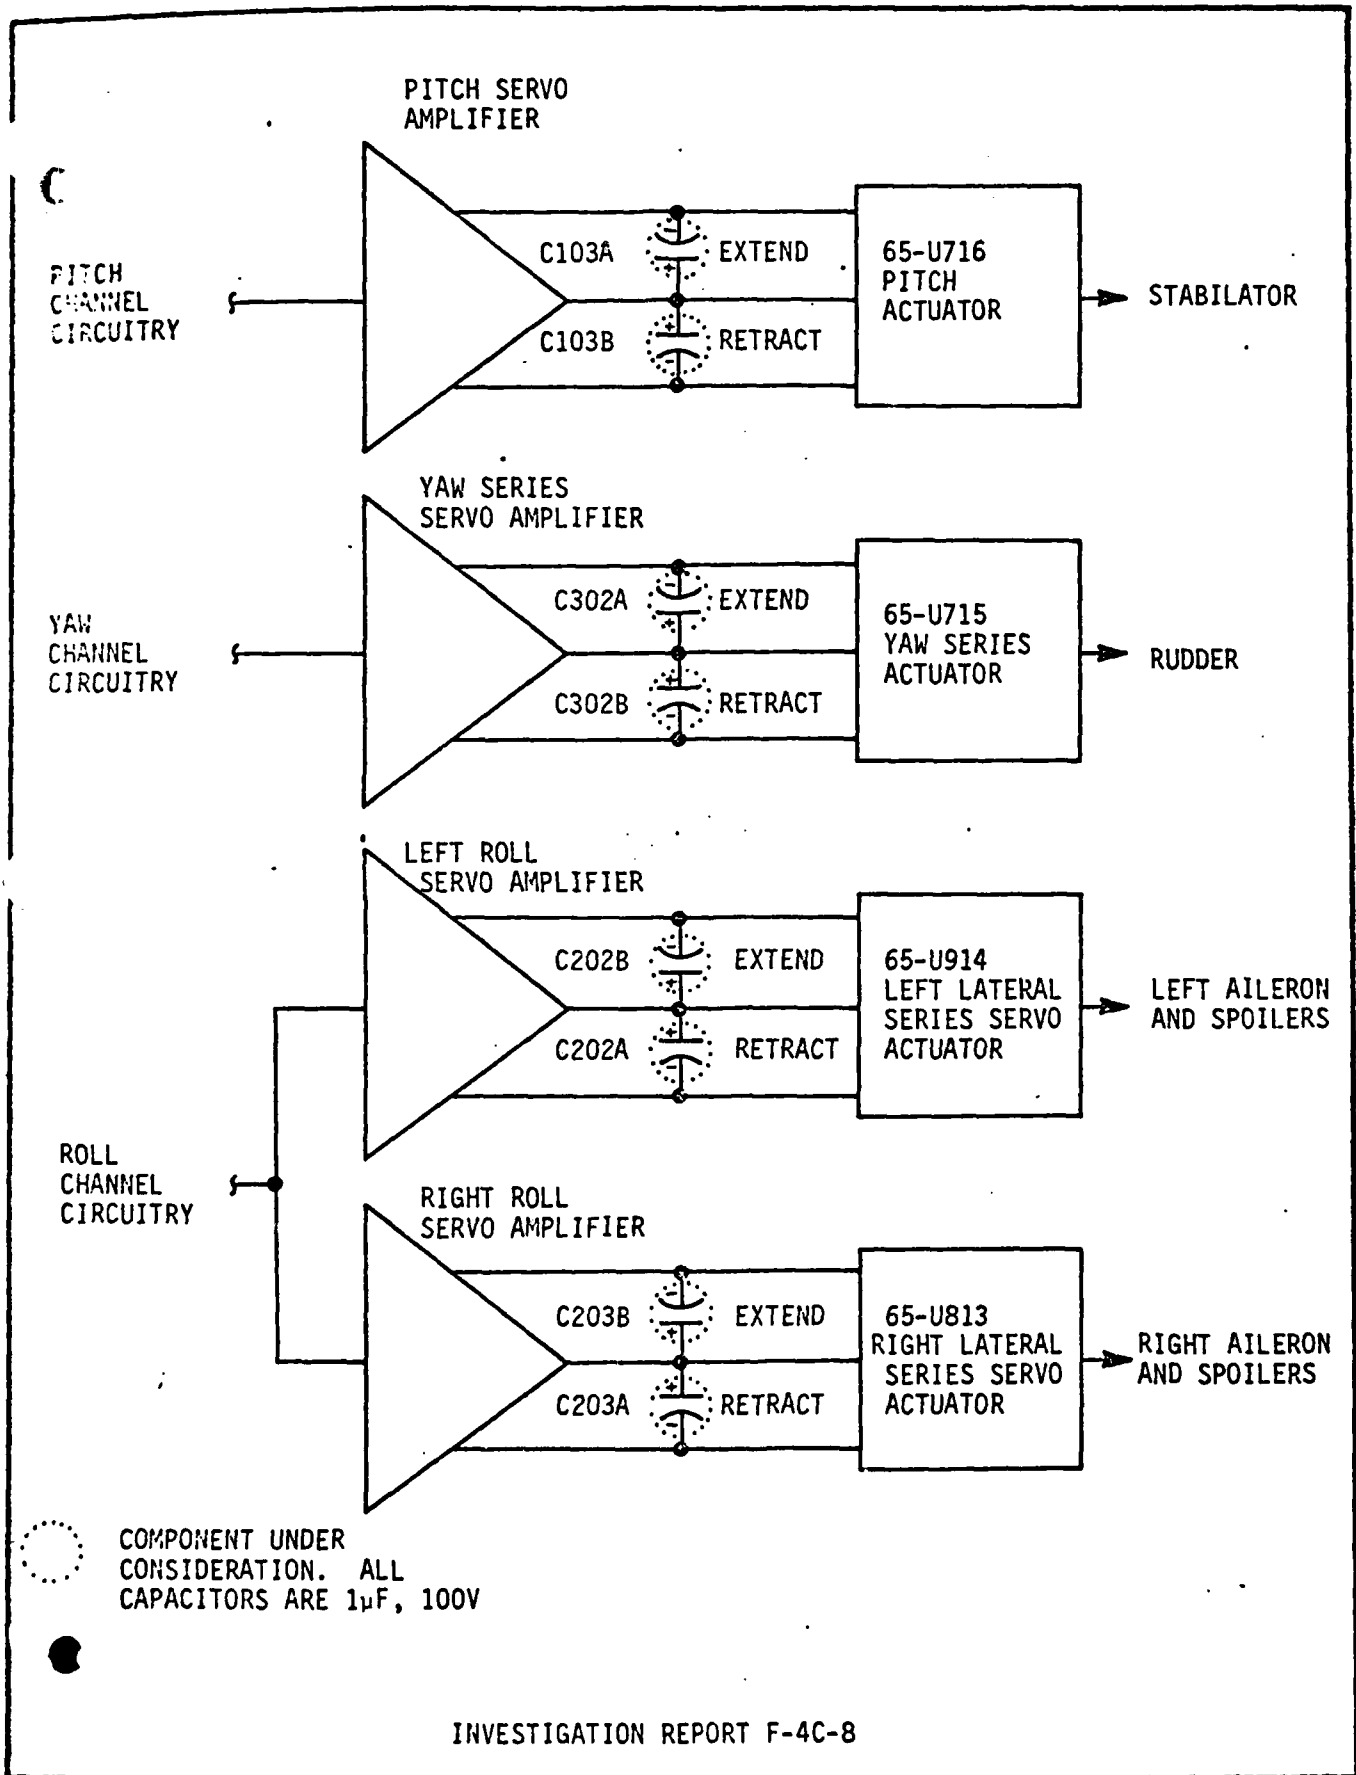
INVESTIGATION REPORT F-4C-8 (Continued)

If capacitor C203A in the roll channel fails shorted, it will short the retract coil of the Right Lateral Series Servo Actuator. This will cause the Right Aileron Actuator to extend to its limit, moving the right aileron and spoilers to the full down position, causing the aircraft to roll left.

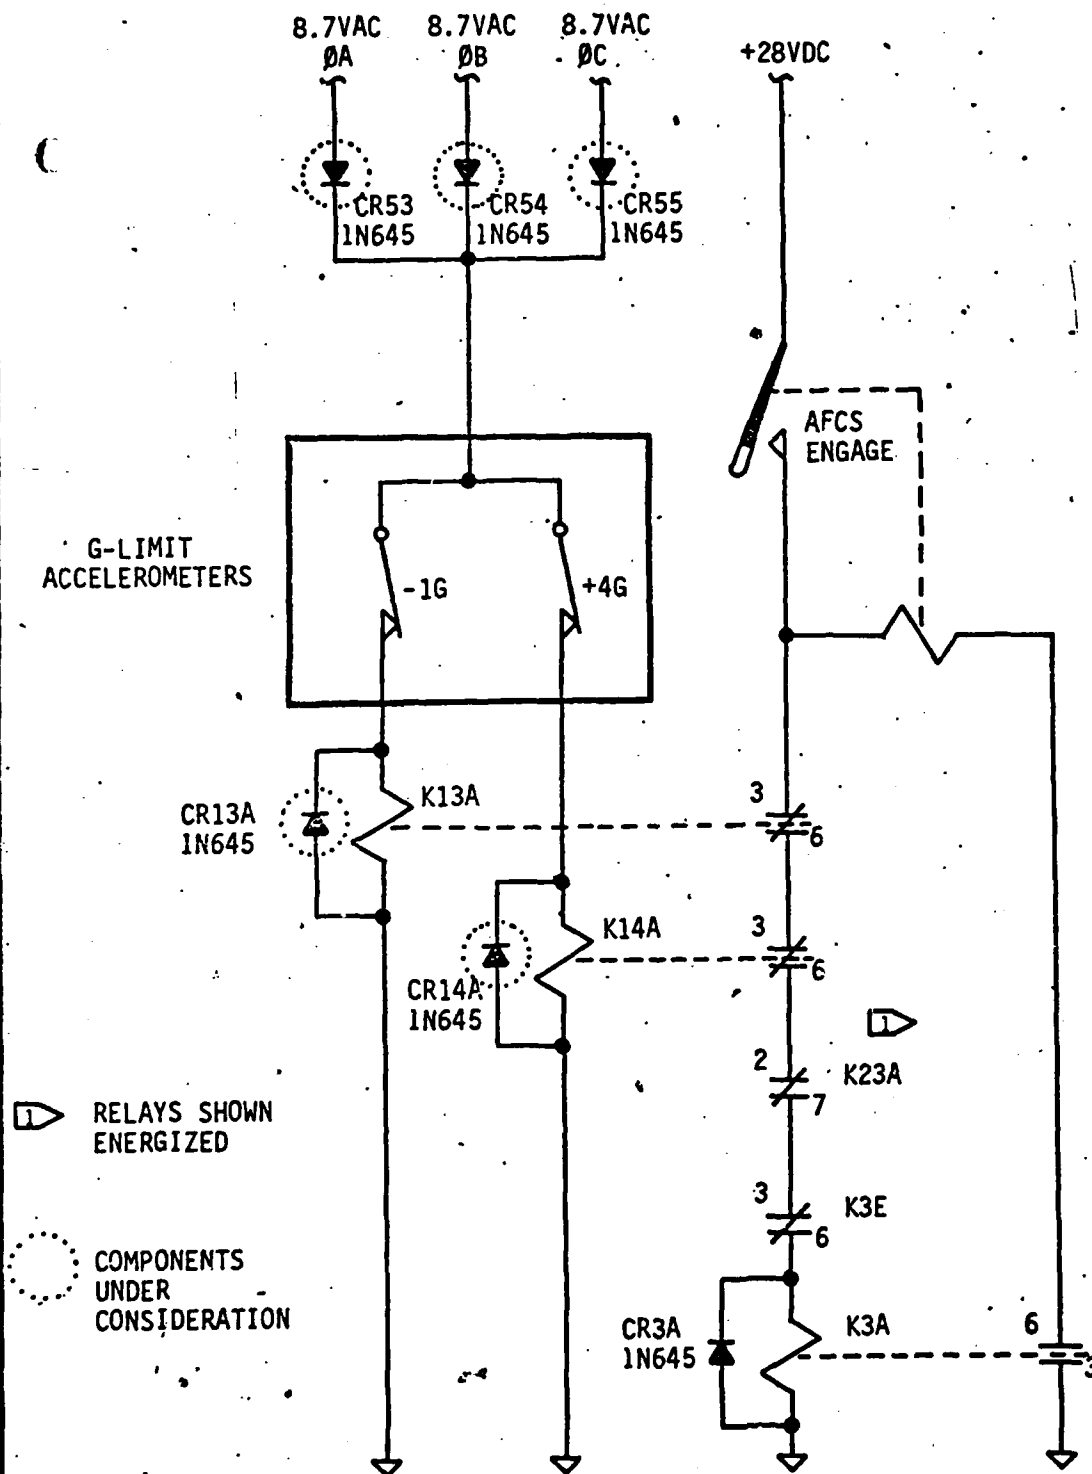
INVESTIGATION REPORT F-4C-9

If any of the diodes CR53, CR54, or CR55 in the chassis wiring fail in the shorted mode (then open) damage to diodes CR13A and CR14A will occur. Loss of CR53, CR54, or CR55 results in insufficient voltage being applied to relays K13A and K14A thus causing them to deenergize. When this occurs AFCS will be disengaged.

This failure mode applies to Control Amplifier, P/N 230E420G3, and earlier. This failure is discussed in greater detail in Design Concern Report F-4C-13.

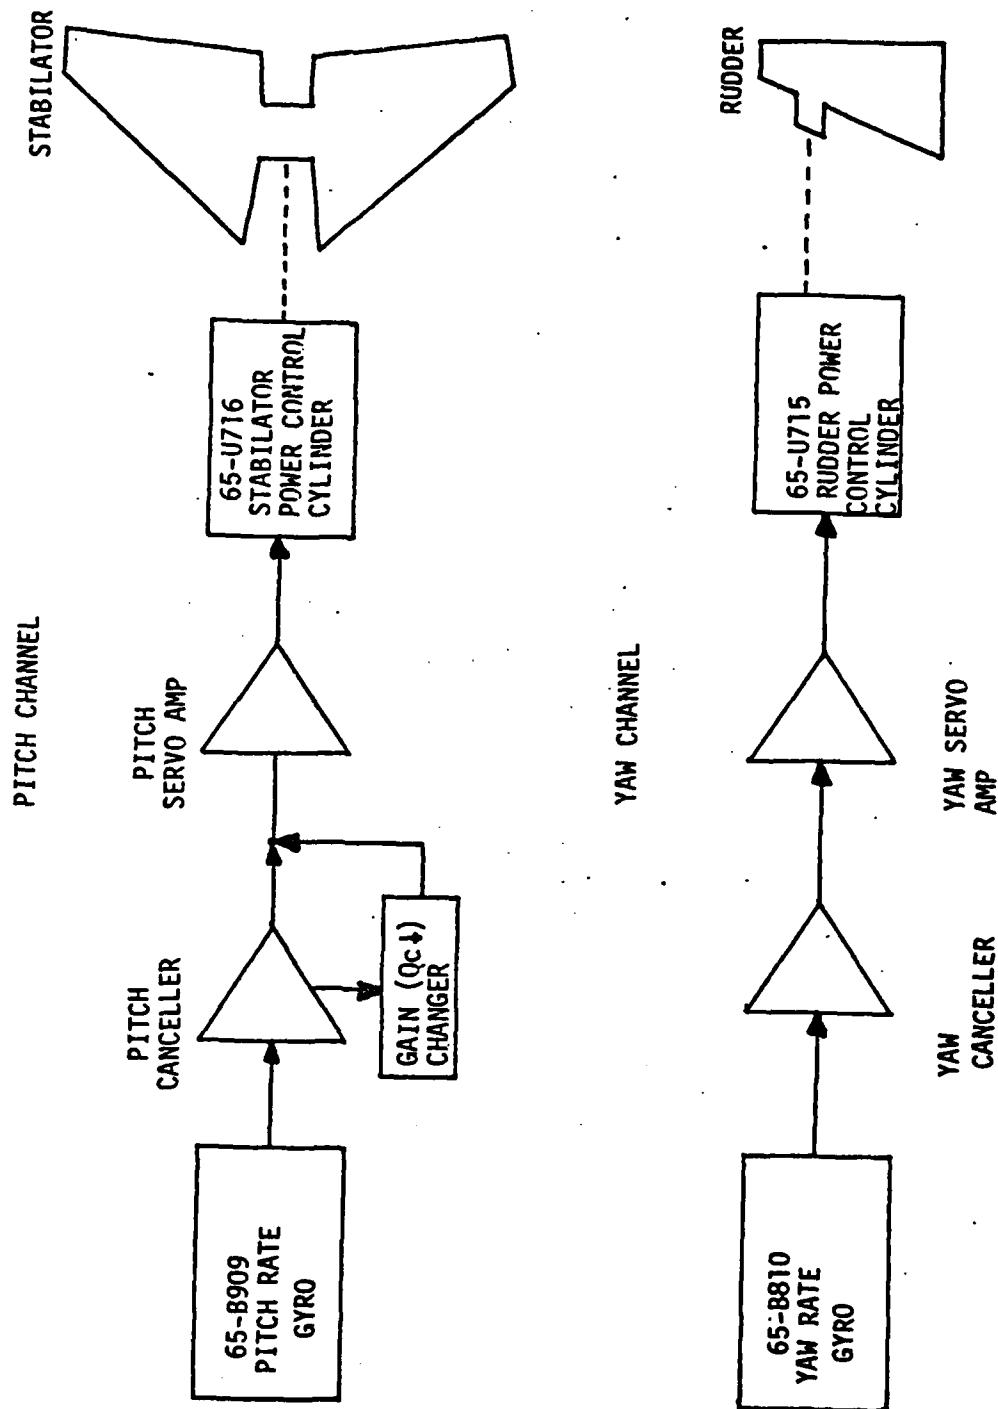
INVESTIGATION REPORT F-4C-12

The error signal from the Yaw Rate Gyro goes to the Yaw Cancellor. The signal from the Yaw Cancellor goes to the Yaw Servo Amplifier. The Yaw Servo Amplifier controls rudder movements.

With the Yaw Cancellor disabled as described in Investigation Report F-4C-11, the Yaw Rate Gyro Pickoff will have no affect on rudder movement, thereby not being able to compensate for aircraft yaw oscillations.

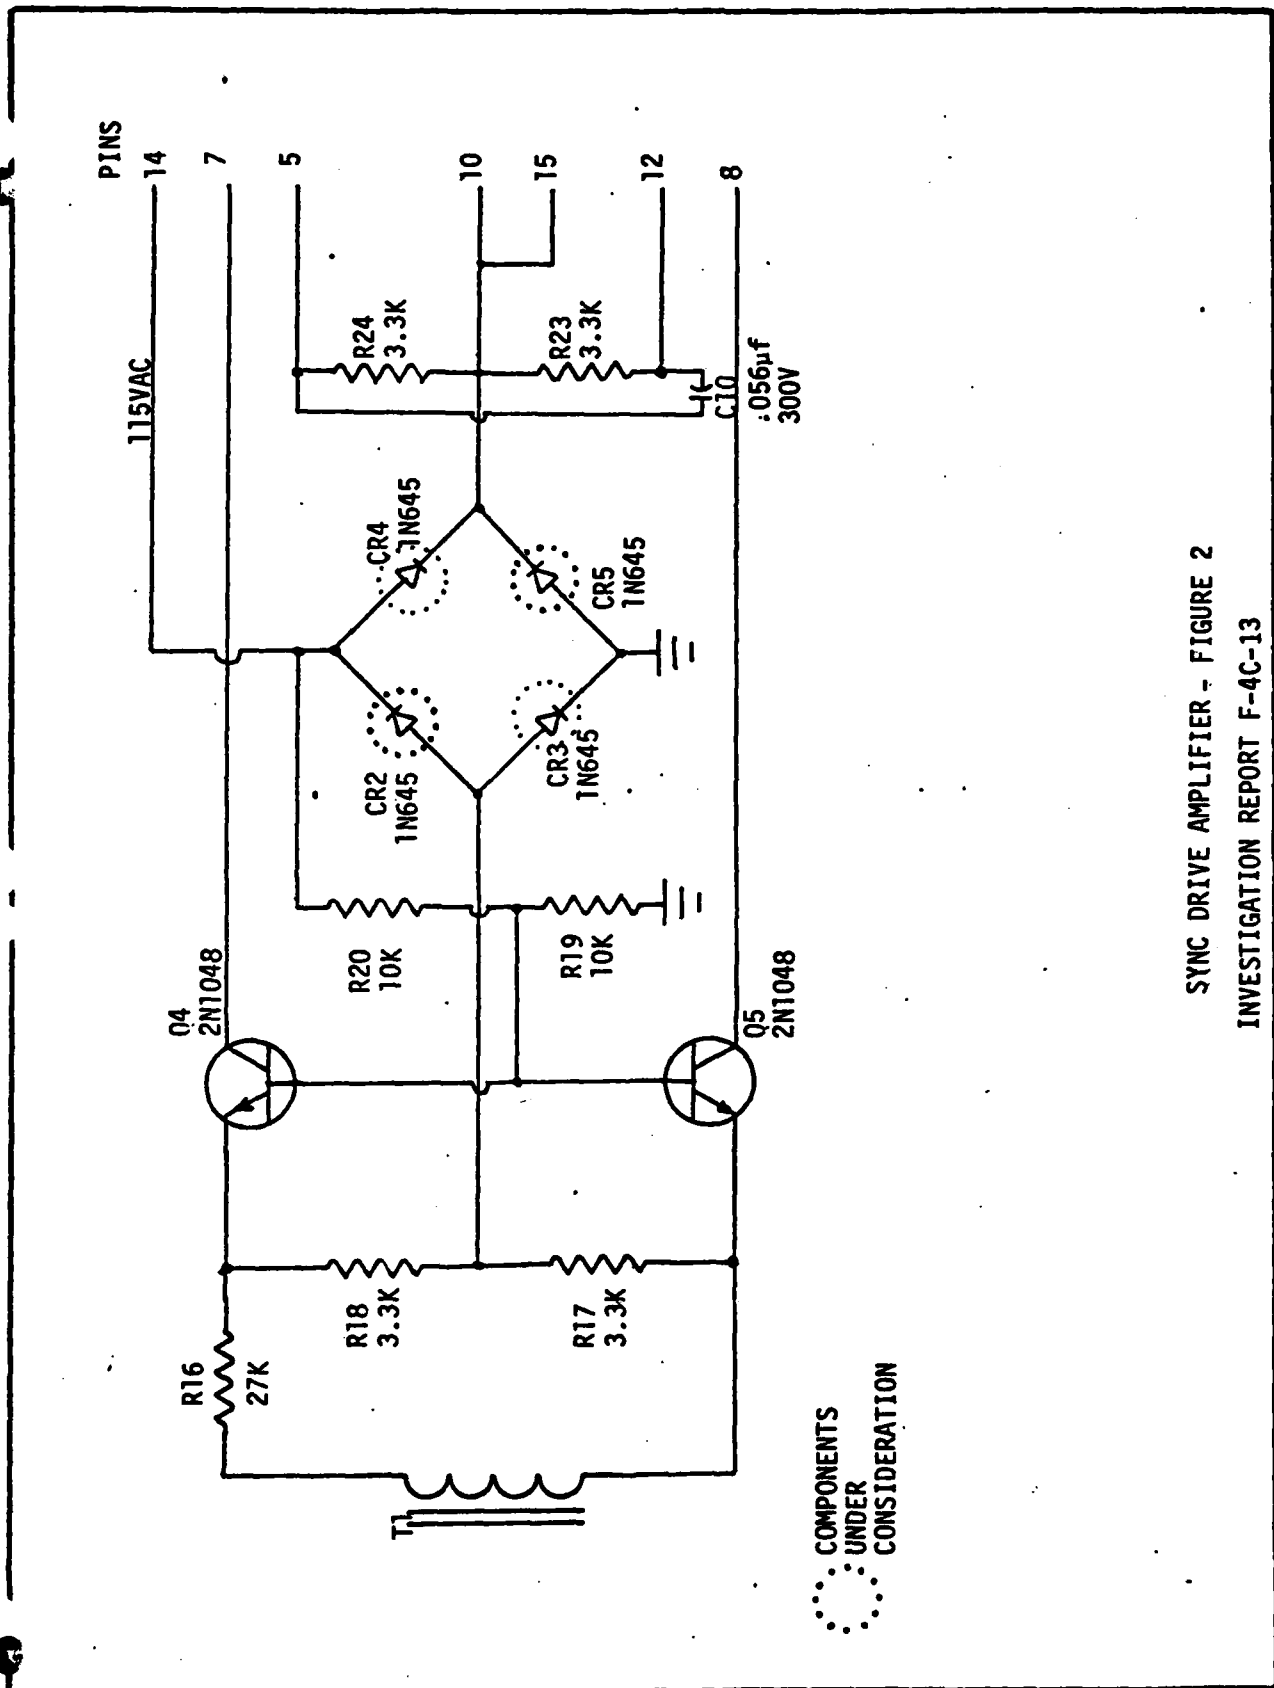
SYNC DRIVE AMPLIFIER - FIGURE 2
INVESTIGATION REPORT F-4C-13

If the pair of diodes CR2-CR4, CR3-CR5, CR2-CR3, or CR4-CR5 or if more than two diodes fail there will be no output signal from the sync drive amplifier.

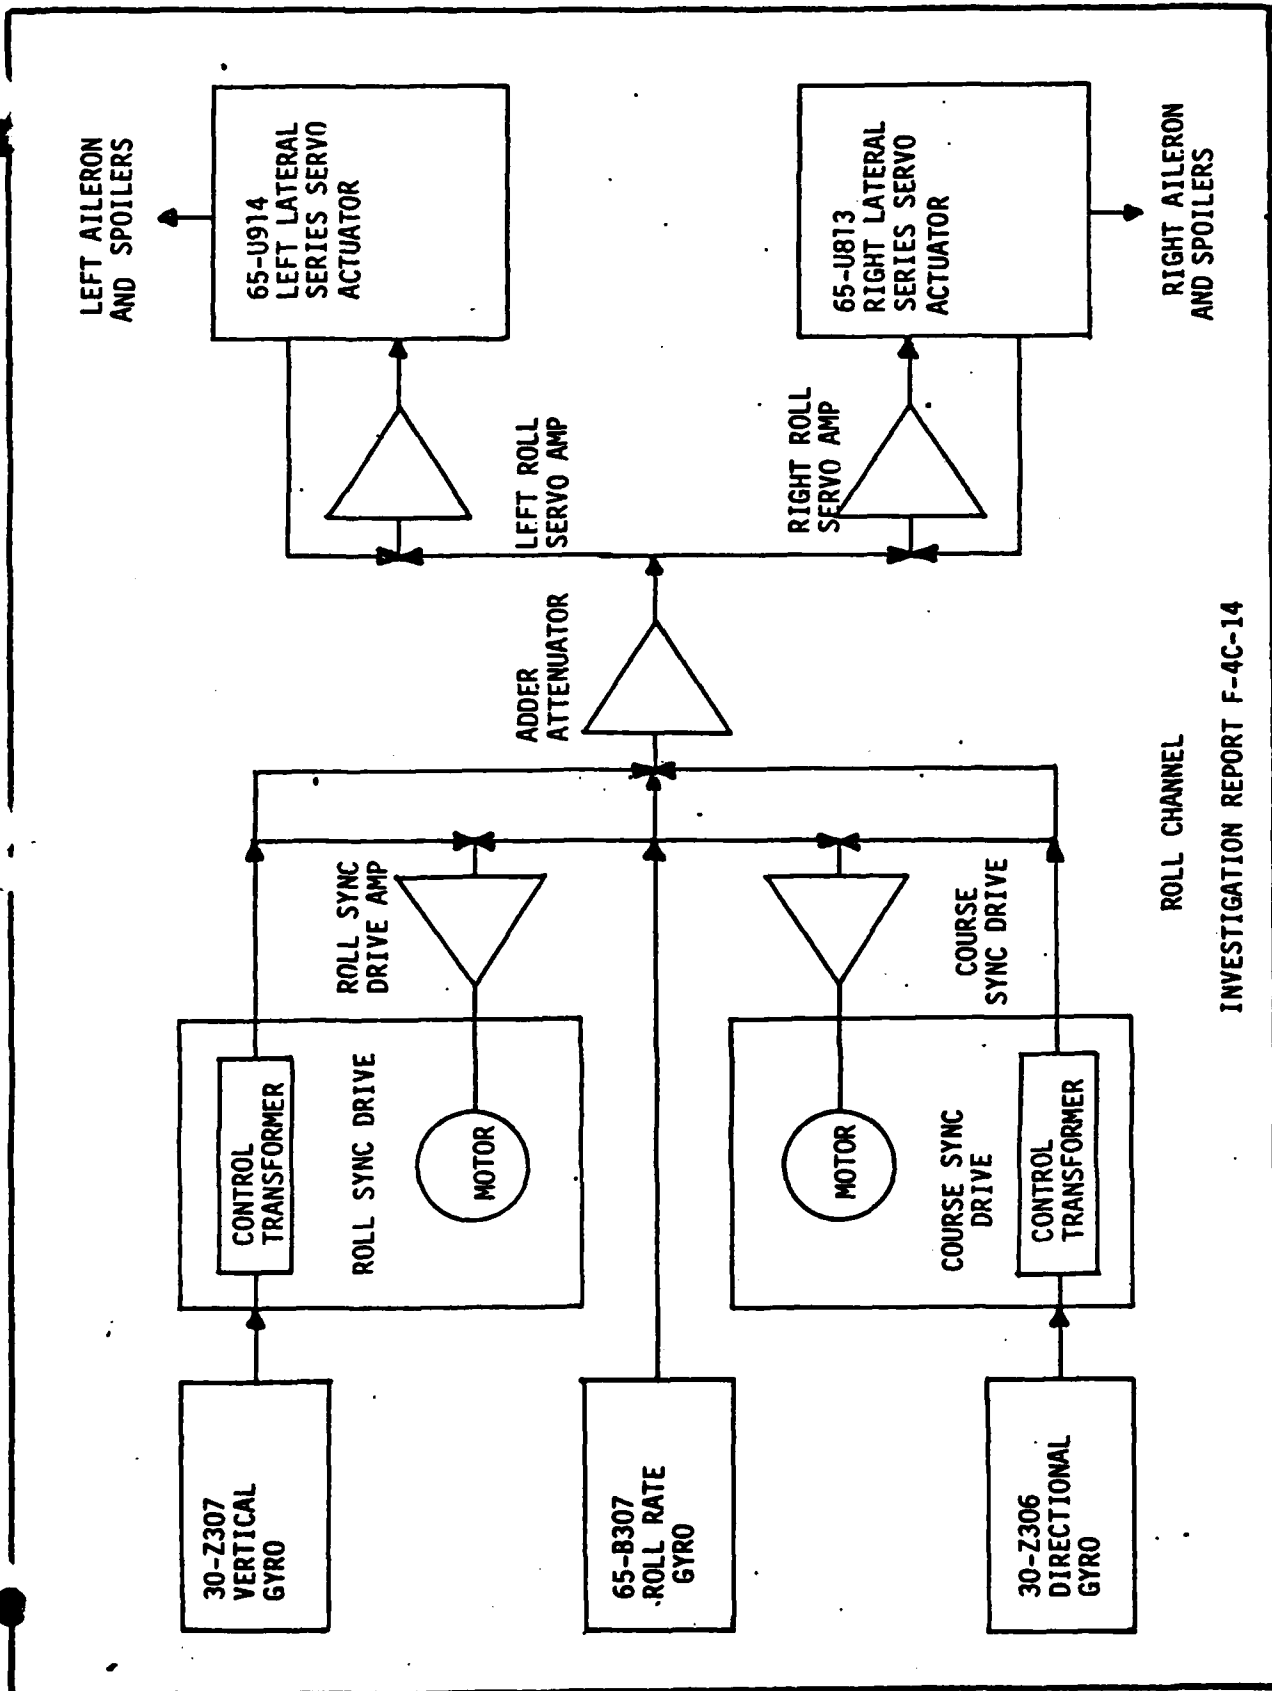
ROLL CHANNEL
INVESTIGATION REPORT F-4C-14

The signal from the control transformer goes to the Adder Attenuator. The output of the Adder Attenuator goes to the Left Roll Servo Amplifier and to the Right Roll Servo Amplifier. The output of the servo amplifiers go to their respective servos, the Left Lateral Series Servo (Ref. Des. 65-U914) and the Right Lateral Series Servo (Ref. Des. 65-U813). The servos control their respective ailerons and spoilers.

The attitude for which the Roll Sync Drive is set when the Roll Sync Drive amplifier is disabled, will be the only attitude the channel will hold. The attitude cannot be changed. If the AFCS is engaged with the Roll Sync Drive Amplifier disabled, the aircraft will attempt to assume the last roll attitude held by the roll channel before amplifier failure.

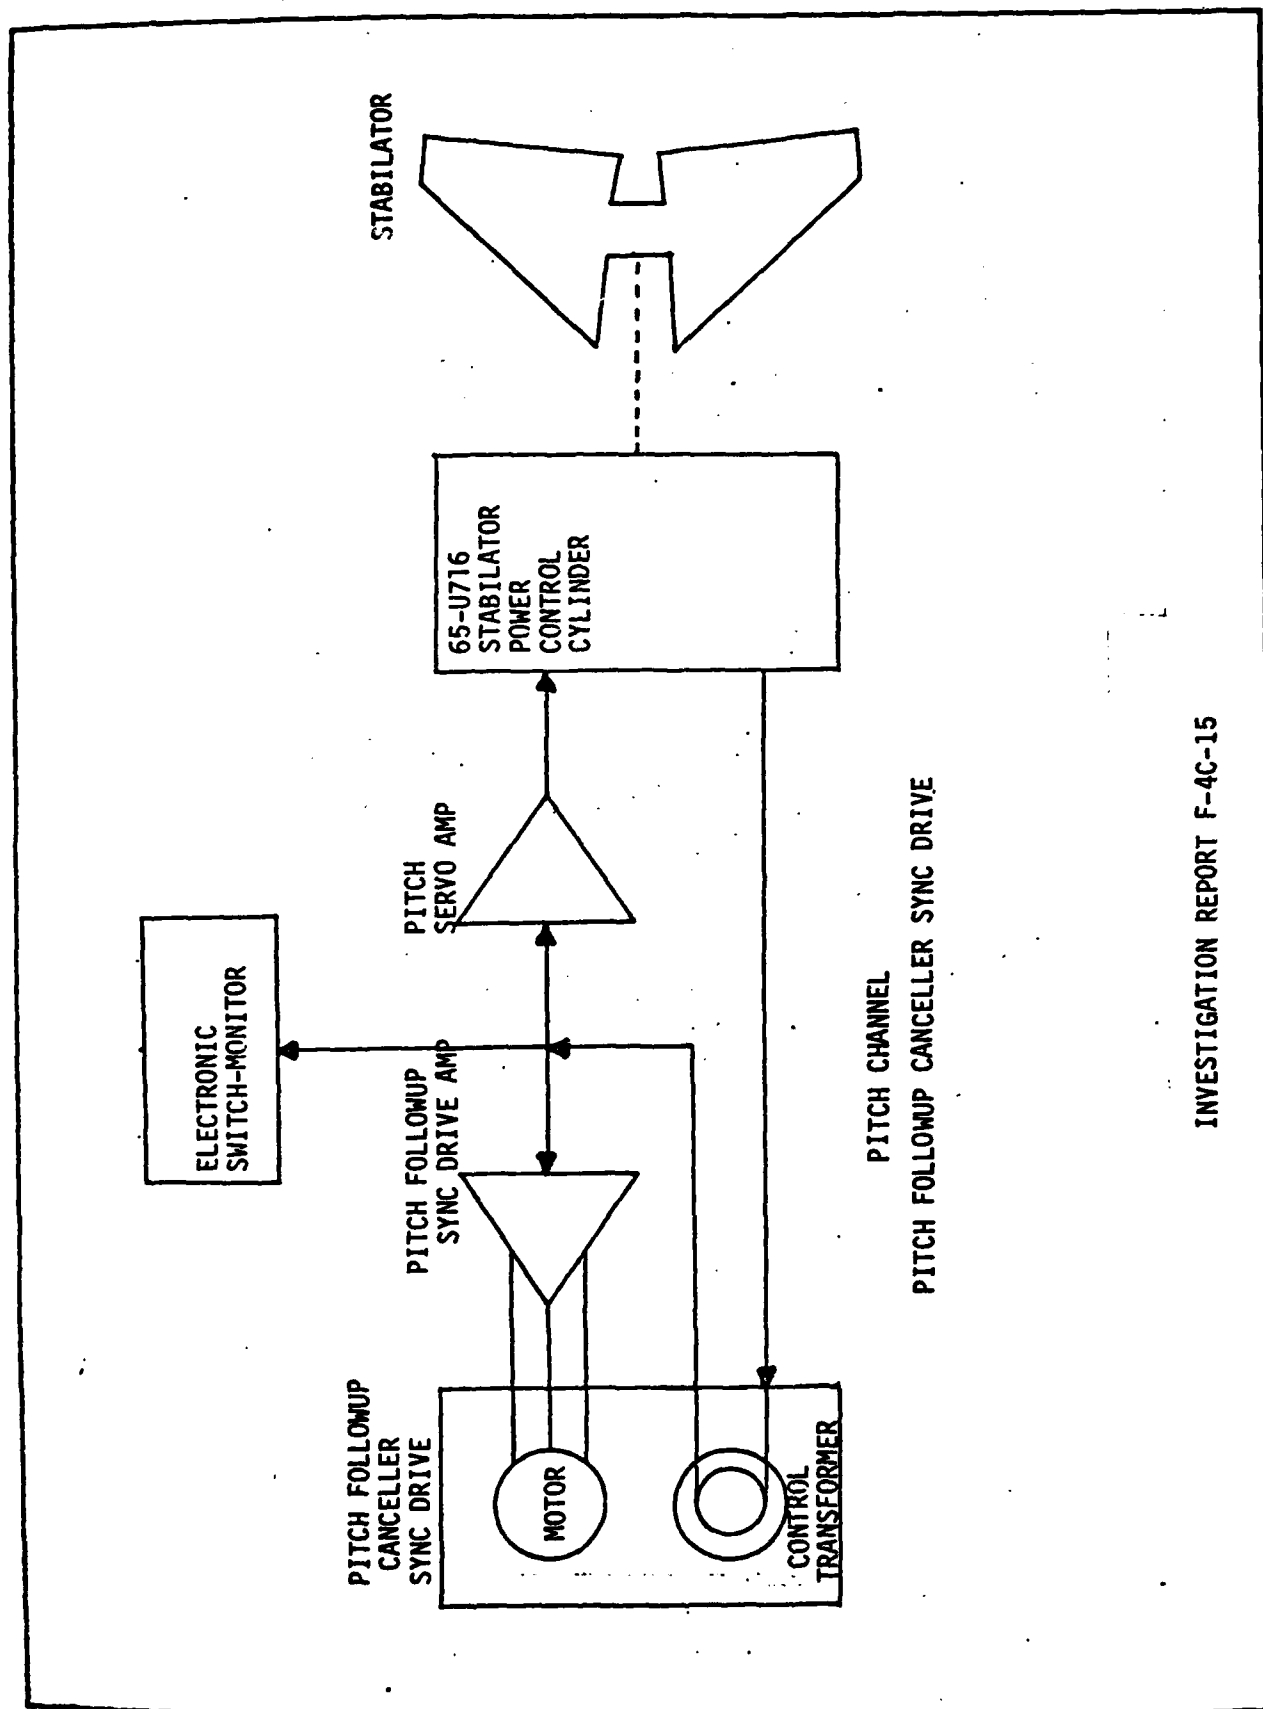
INVESTIGATION REPORT F-4C-15

If the Sync Drive Amplifier is disabled before AFCS engagement, the uncorrectable error voltage from the Pitch Follow-up Cancellor control transformer or main ram follow-up will be detected by the Electronic Switch-Monitor thus preventing AFCS engagement. For the special case where the stabilator is positioned such that it cancels the error voltage from the control transformer, the AFCS can be engaged but the pitch attitude will not be maintained.

In either case of the Sync Drive Amplifier being disabled, before or after AFCS engagement, the pilot will have to manually adjust pitch to compensate for changes in the aircraft configuration.
